URGENT MEDICAL DEVICE RECALL

PowerPort™ duo M.R.I.™ Implantable Port Kits

March 25, 2021

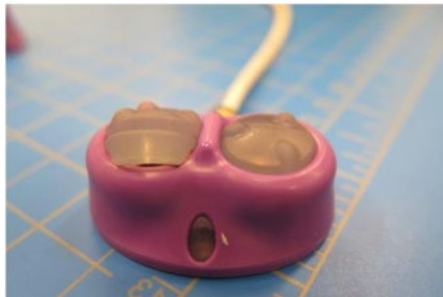
BD has recently received reports of difficulty in flushing, infusion, and / or aspiration, and septum dislodgements during use of the above referenced PowerPort duo M.R.I. Implantable Ports. An example of a dislodged septum can be seen in Figure 1, on the following page.

A dislodged septum can result in leakage of infusates into the port cavity of the patient where the implanted port resides. Depending on the detectability of the leak and the volume and type of infusate, this situation may lead to a varying degree of pain and injury to the patient. In the case of an irritant or vesicant solution, a leak could produce serious toxic and or necrotic injury requiring immediate intervention to remove the port and treat the underlying affected tissue. The difficulty and/or inability to flush, infuse or aspirate can cause a delay in therapy and/or additional medical intervention. Both product issues can lead to port abandonment and may require surgical removal and or replacement of the port.

Figure 1: Dislodged Septum

If any difficulty is encountered in flushing, infusion, and / or aspiration with either lumen of an implanted port, the affected port lumen should be considered non-functional and the remaining lumen should be verified for patency. After evaluation a non-patent lumen should be abandoned. Clinicians and physicians should use sound medical judgement and a risk versus benefit assessment in each individual case to determine the appropriate time for explantation.

1. Please check all inventory locations within your institution for the specific catalog and lot numbers of the PowerPort duo M.R.I. Implantable Ports listed above and immediately destroy all affected product remaining in your possession.
2. Share this notice with any users of the product within your facilities to ensure they are also aware of this Urgent Medical Device Recall.
3. If you purchased this product from a distributor, contact your distributor for further instructions.
4. **Complete and return the attached Customer Response Form to the BD contact noted on the form** confirming acknowledgement of the recall notification, whether or not you have any affected product, so that BD may acknowledge your receipt of this notification and process any applicable replacement orders.
